# Conservation of wall paintings of Ram Mandir, Battisputali

- Om Prakash Yadav

#### **Conservation Procedure:- A case study of the wall paintings of Ram Mandir, Battisputali**

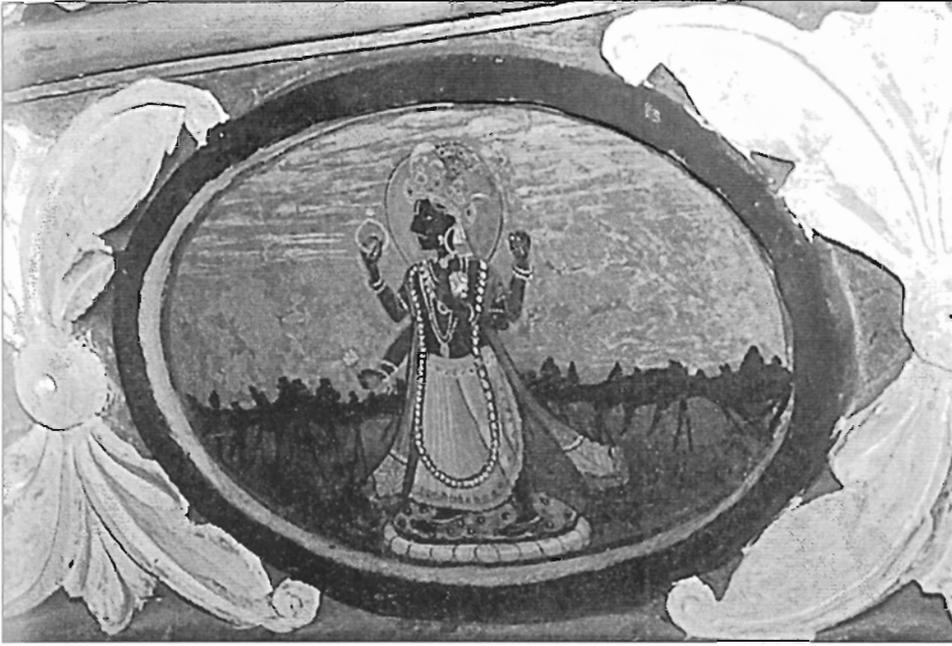
Before Conservation

After photographic documentation, the conservation of wall paintings was carried out in six steps:-

Step 1:- Dry cleaning with soft camel hair brush was carried out.

Step 2:- Using 20% solution of Fevicol (polyvenyl

acetate emulsion), the bulged plaster was refixed carefully.

Step 3:- Solvent cleaning using different organic solvents like ethanol, 20% butylamine, dimethylformamide, thinner, 2% ammonia, mechanical cleaning with a special type of scalpel was carried out wherever it was thought to be necessary.

Step 4:- Missing plaster layer, wide cracks were filled by using plaster of paris along with PVA emulsion solution.

Step 5:- Re-integration was carried out wherever it was thought to be necessary. For this water color of standard company was employed.

Step 6:- A final preservative coating using 3% solution of PVA in sulfur-free toluene was applied.

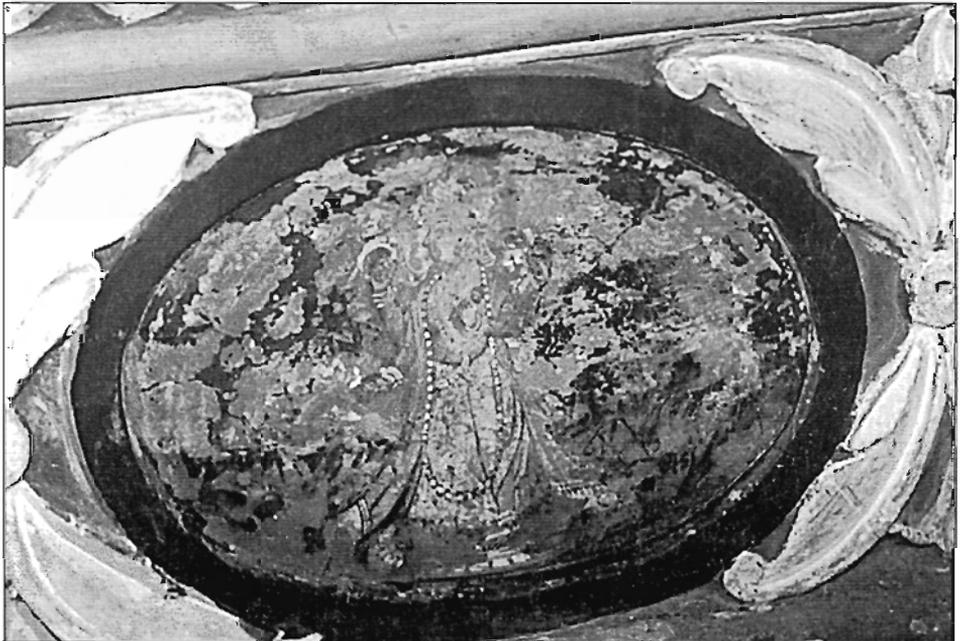
Before Conservation
